Aircraft Materials Technical Memorandum 396

CRACK DISTRIBUTION AND GROWTH RATES FOR
CRITICAL FASTENER HOLES IN MIRAGE WING RH79 (J)

S. BOWLES

SEPTEMBER 1987

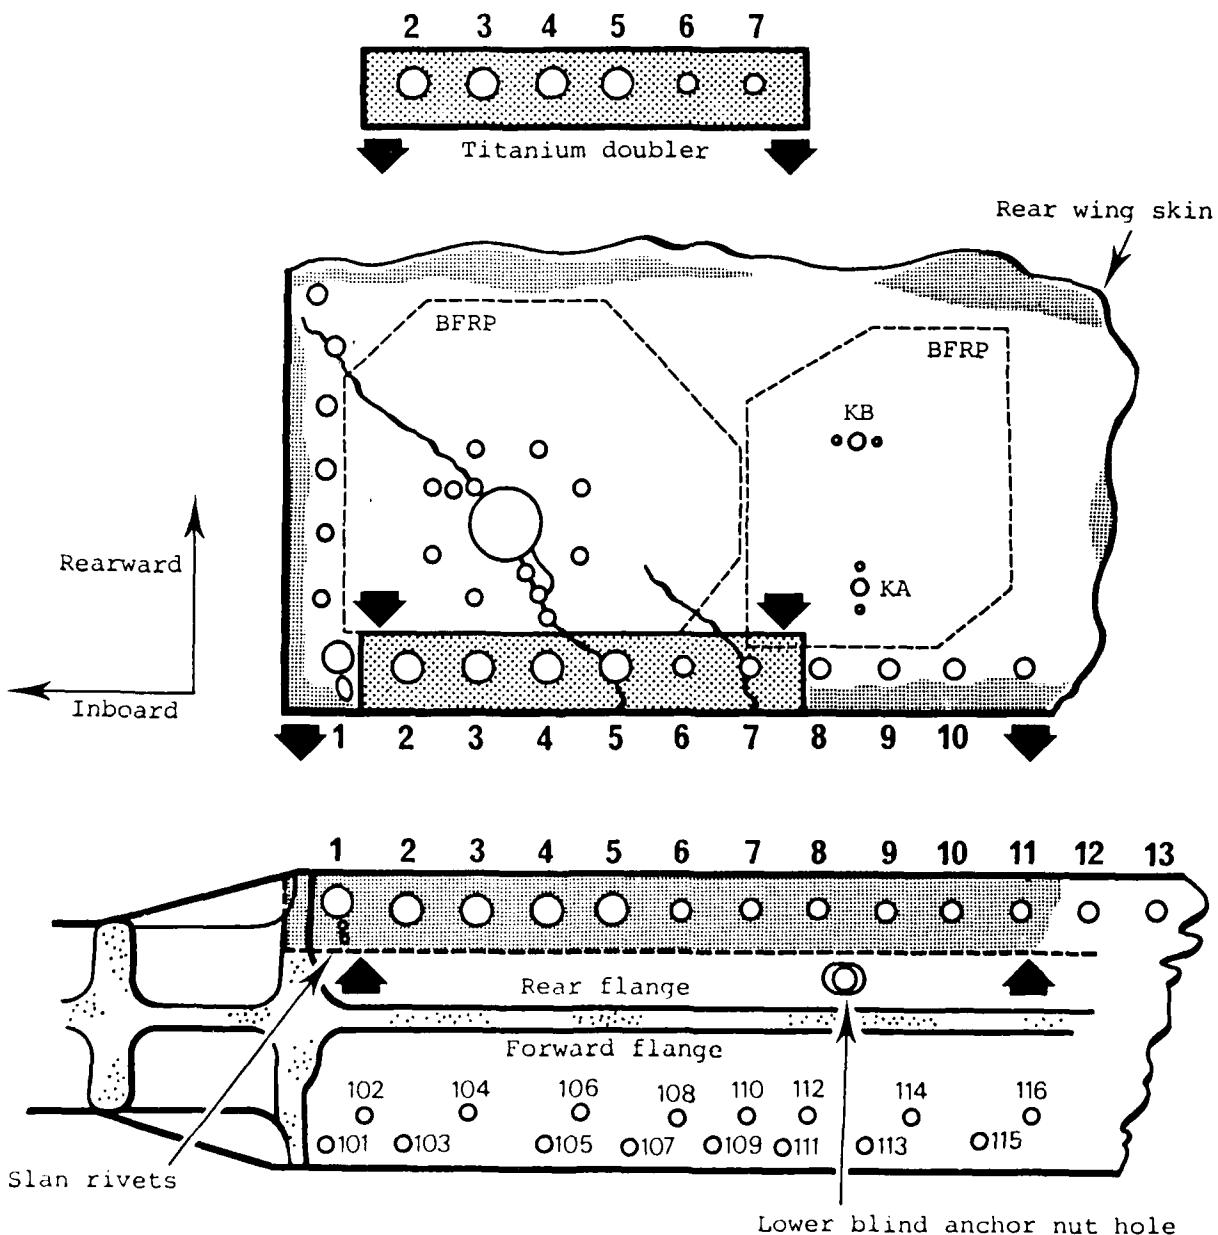
FIG. 1 LOCATION OF FASTENER HOLES IN THE MIRAGE WING-SPAR (LOWER FLANGE) AND THE ATTACHED REARWARD WING-SKIN.

Overall, this fractographic information shows that the pattern of crack distribution is much as expected, with the largest cracks occurring on the rearward flange; the greatest cracking activity occurred in the SLAN rivet holes [2]. Holes 1 to 4 remained crack-free; this indicates that the bushes installed during refurbishment were effective since from past experience holes in these positions are normally critical crack initiation sites. For the remaining rearward flange holes inspected, cracking activity was more prominent in the holes towards the outboard end of the spar: holes 10, 11, 12, 13 and the blind-anchor-nut hole. This may result from a load redistribution due to either the large cracks found growing in the rearward wing-skin or the boron-fibre reinforced patches on the wing skin (see Figure 1). The most active crack in the forward flange occurred in fastener hole 104, which seems to carry the main load from the forward fairing.

BORON FIBRE REINFORCED PATCHES (BFRP) AND A TITANIUM DOUBLER USED IN SKIN REPAIR ARE SHOWN. MAJOR SKIN CRACKS ARE ALSO SHOWN.

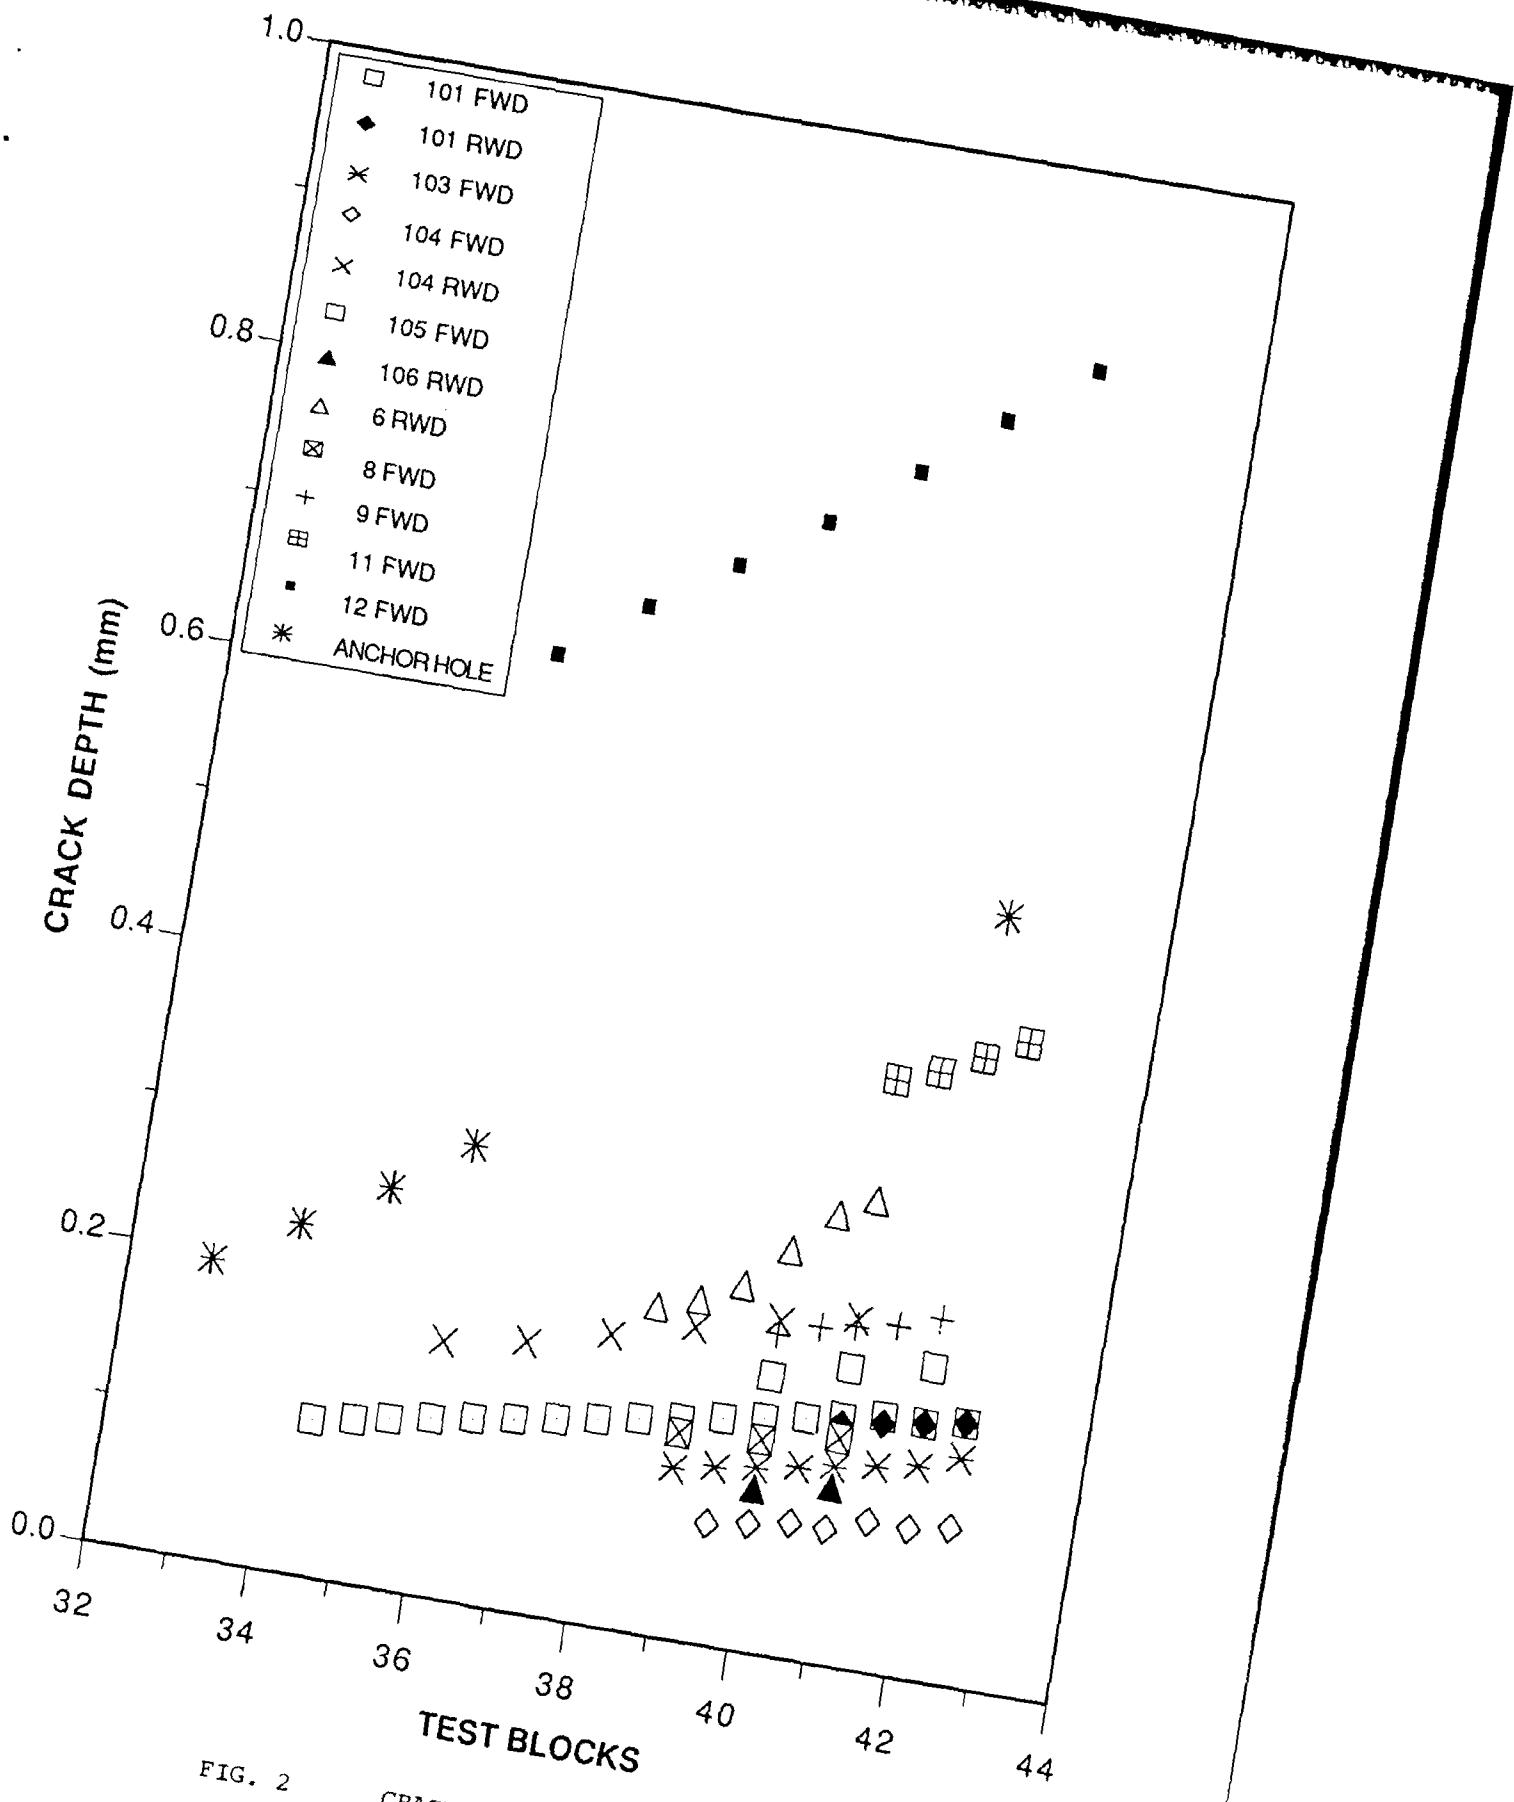
FIG. 2

The largest crack observed in the rearward spar flange holes was 2.18 mm deep (in hole 10), while the largest crack observed in the forward spar flange holes was only 0.27 mm deep (in hole 104.)

Crack growth curves for cracks in holes 6, 8, 9, 11, 12, blind-anchor-nut hole, 101, 103, 104, 105 and 106 are presented in Figure 2. Unfortunately many of the crack faces, including those of the crack in hole 10, were severely fretted and crack growth data could not be obtained.

CRACK GROWTH CURVES FOR MIRAGE
WING RH79.
